Mold Inspection Report

**1430 Thompson Heights Avenue - Cincinnati, Ohio
45223**

Inspection Date:
December 4, 2011

Prepared By:
House To Home Enterprises LLC.

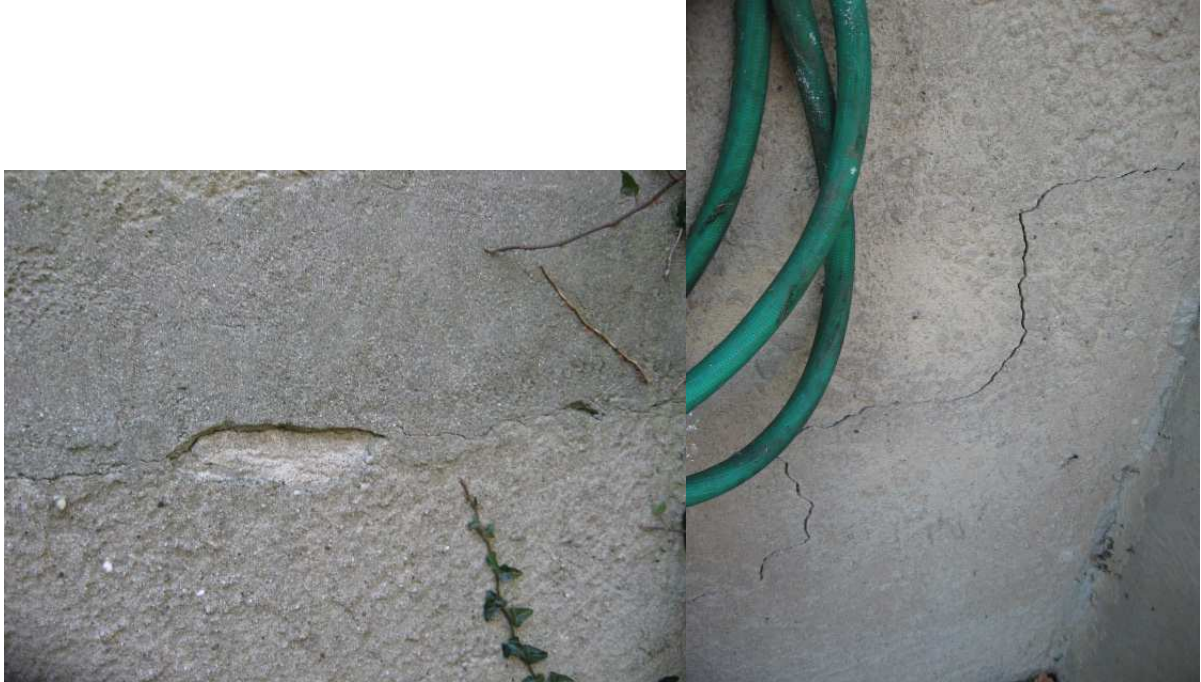
- **Monitor:** Common minor settlement cracks were observed in the foundation walls in various locations.

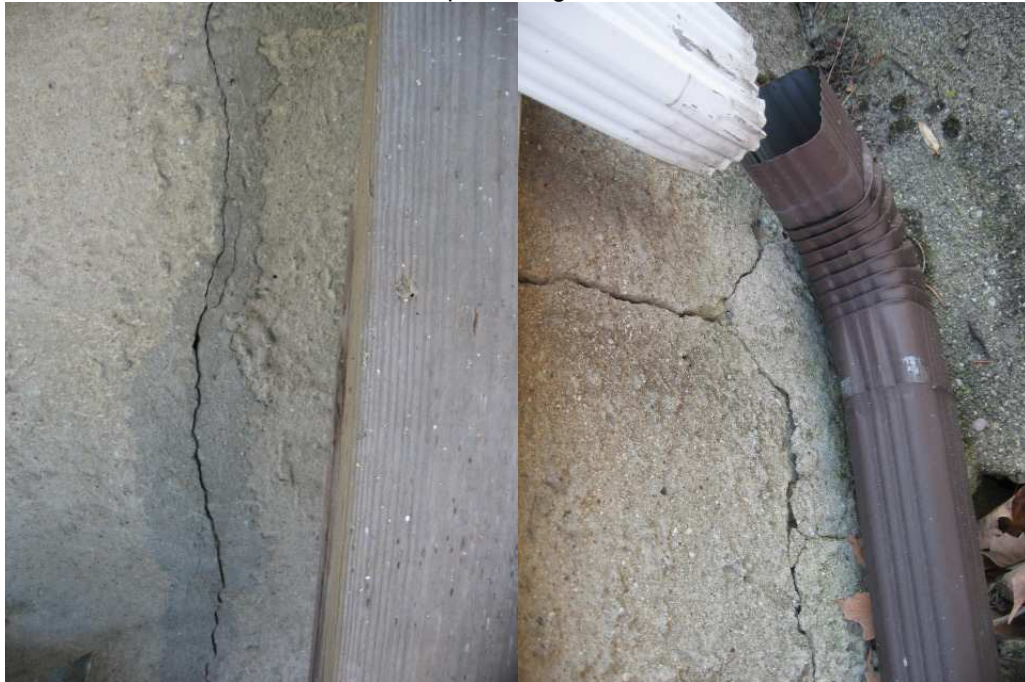
- **Repair:** Larger than typical foundation settlement cracking was observed in various locations. These cracks may have a tendency to leak. House To Home Enterprises LLC recommends repair by a licensed foundation contractor.

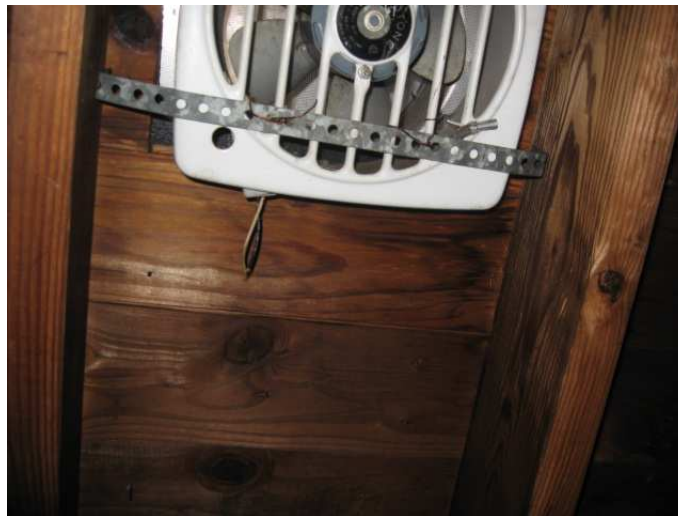
- **Monitor:** Evidence of condensation was observed on the underside of the roof sheathing. Improved roof and attic ventilation (see Insulation and Ventilation) can reduce condensation. During re-roofing, the sheathing should be investigated to determine if replacement is needed. Also, it appears that the attic ventilation fan is inoperable (disconnected wiring).

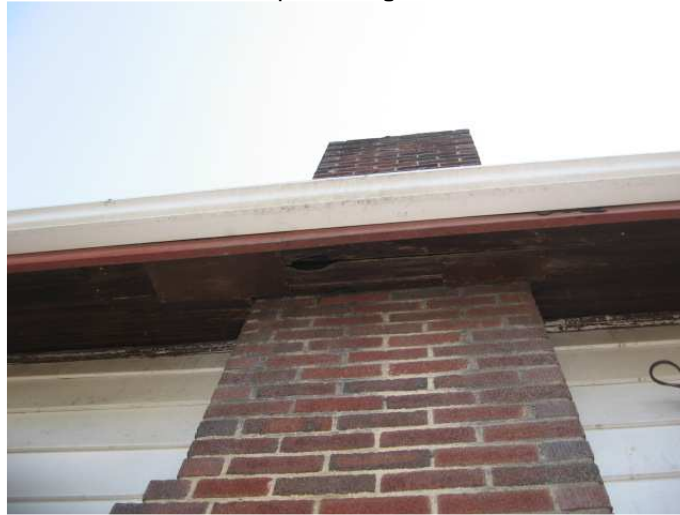
Metal plate installed on soffit

- **Monitor:** Prior repairs to the roof are evident around the chimney. Consult the current owner (if possible) regarding this prior work.

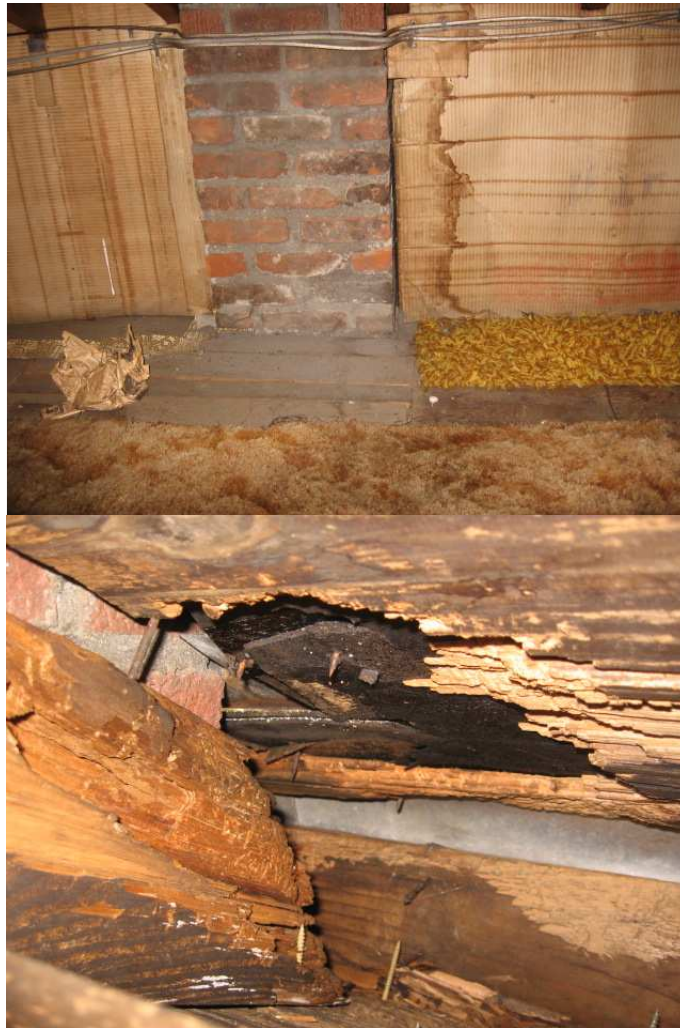
- **Repair:** While investigating the roof structure, outside light was visible around the 2 chimneys. Any openings in the roof/walls should be repaired to avoid leaks.

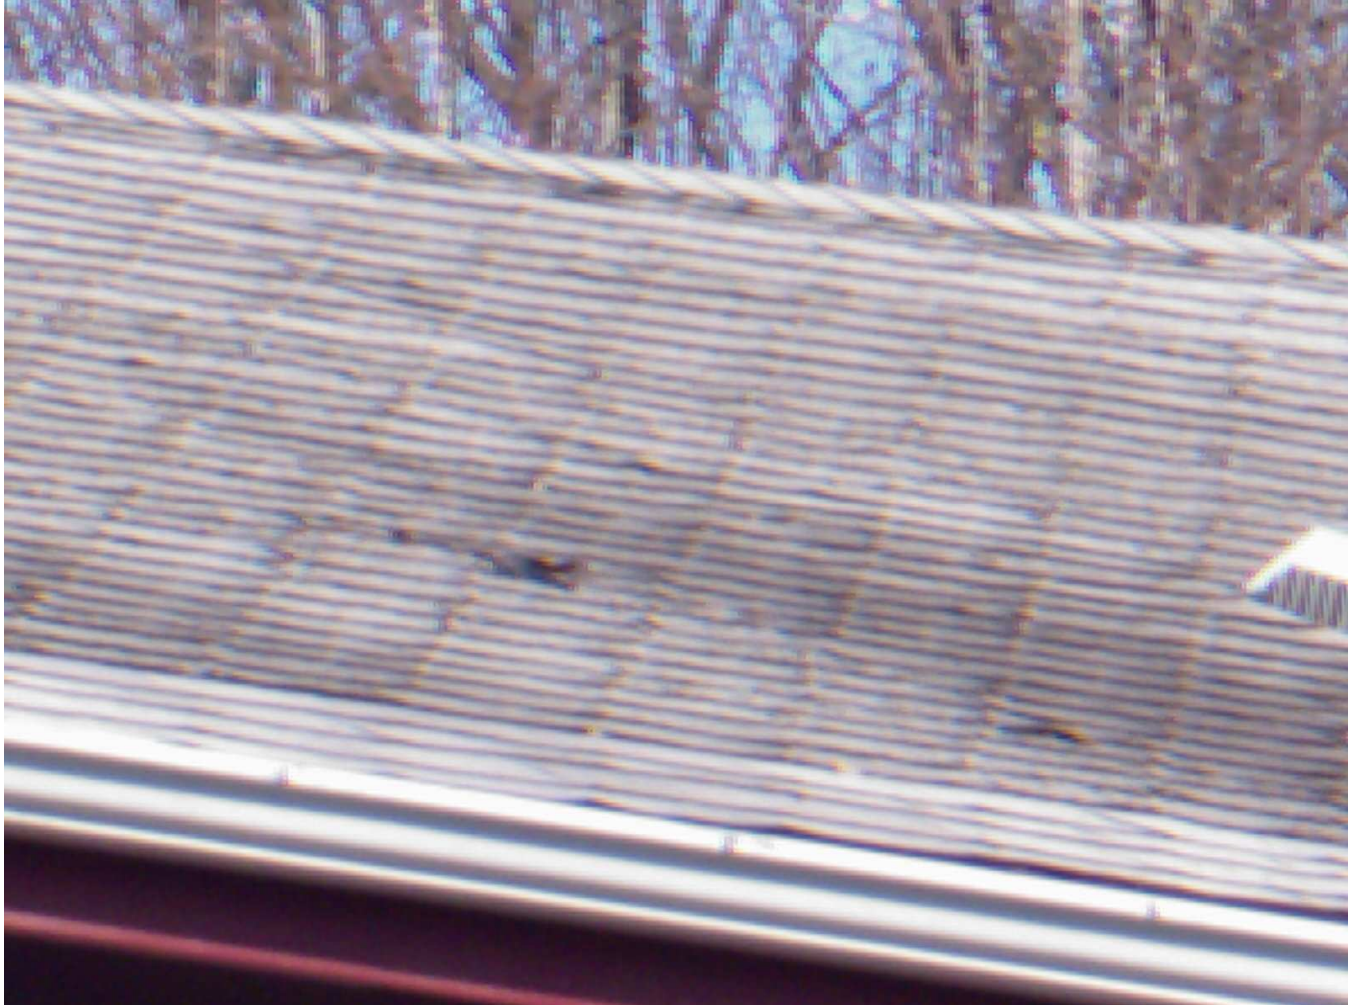
- **Major Concern, Repair:** The roofing is at end of life and should be replaced.

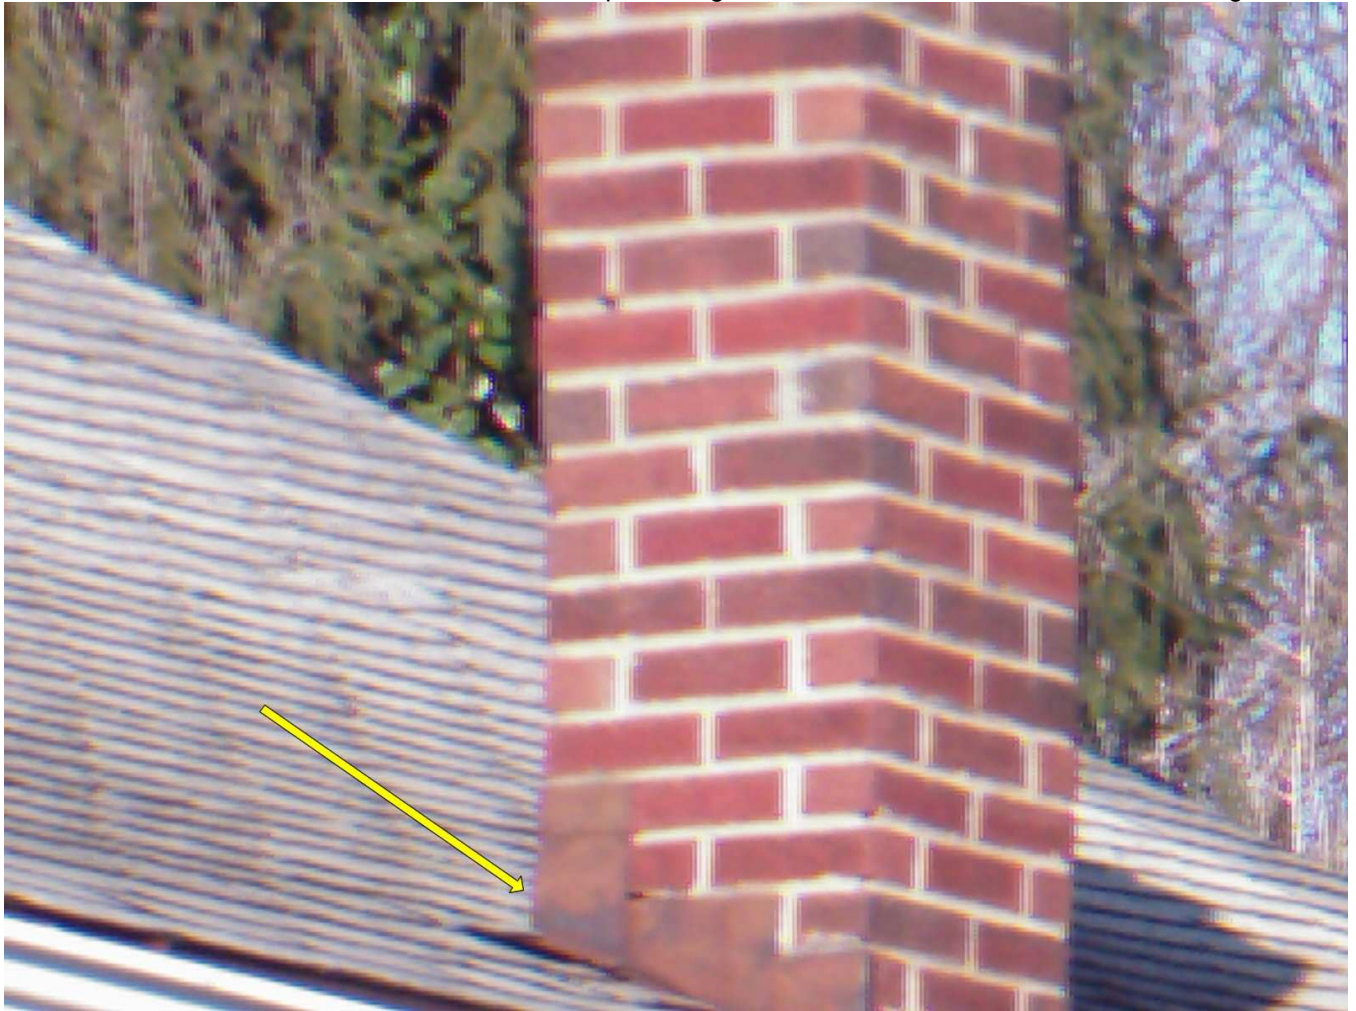
Saddle Flashing(s) Recommended

- **Repair:** The flashings on the entire house are old and should be replaced to avoid leaks. Also, it is recommended that a saddle flashing be installed for the chimney(s).

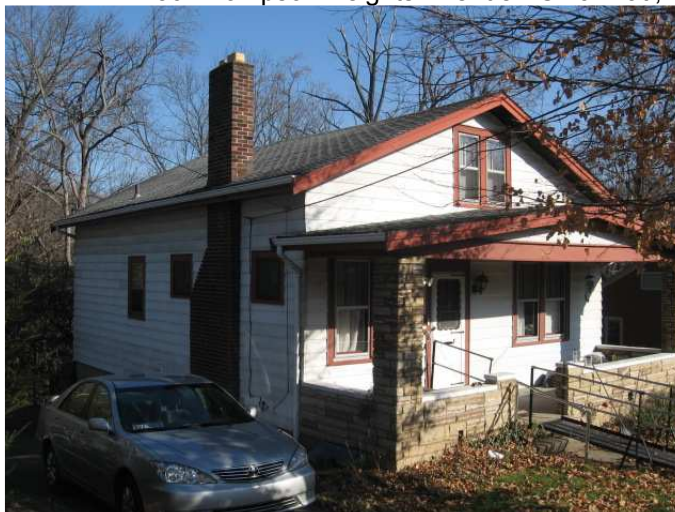
- **Repair:** The gutters require cleaning (as predicted from ground level evidence) to avoid spilling roof runoff around the building – a potential source of water entry or water damage.
- **Repair:** There does not appear to be a sufficient number of downspouts at the upper front slope. If practical, additional downspouts should be installed to avoid spilling roof runoff around the building – a potential source of water entry or water damage.

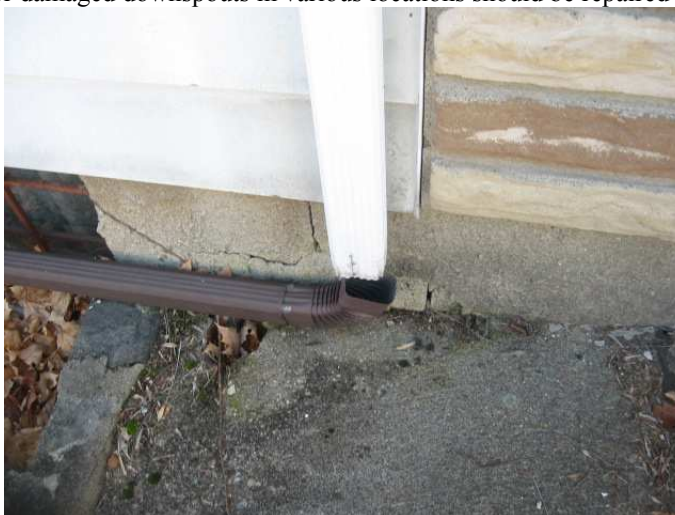
- **Repair:** The downspout(s) in various locations should discharge water at least five (5) feet from the house. Storm water should be encouraged to flow away from the building at the point of discharge.
- **Monitor:** The downspouts that discharge below grade level should be monitored. If they are ever suspected to be clogged or disconnected below grade, they should be redirected to discharge at least five (5) feet from the building. Foundation leakage adjacent to a downspout is an indication of a problem below grade.
- **Repair:** Loose, missing or damaged downspouts in various locations should be repaired promptly.

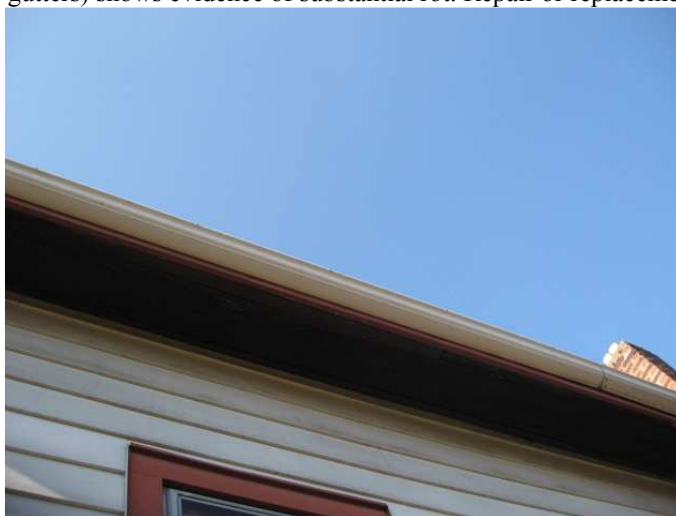
- **Repair:** Damage to the eave is suspected to be the result malfunctioning gutters/downspouts.
- **Repair:** The soffits and perhaps fascia (the wooden board to which the gutter is typically fastened) - (although inconclusive – covered by gutters) shows evidence of substantial rot. Repair or replacement is needed.

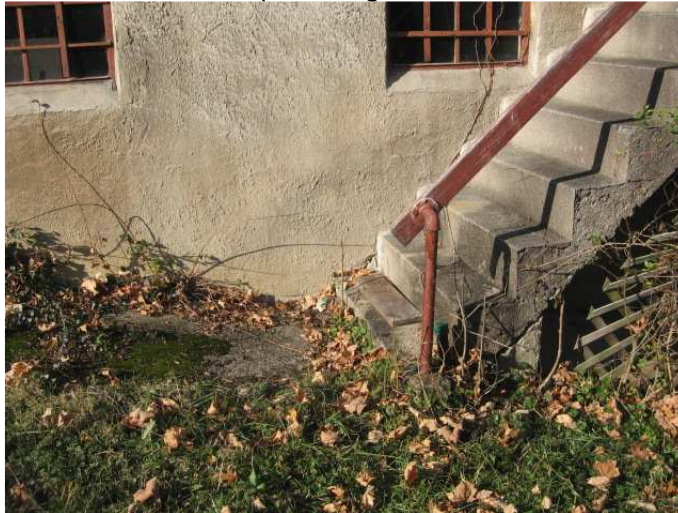
- **Major Concern, Repair:** The grading in various locations should be improved to promote the flow of storm water away from the house. This can often be accomplished by the addition of top soil. The ground should slope away from the house at a rate of one inch per foot for at least the first ten feet. At least eight (8) inches of clearance should be maintained between soil level and the bottom of exterior wall siding.
- **Possible Major Concern, Monitor:** The walkway appears to slope towards the house in various locations. This condition can cause water entry in the building. It is difficult to improve this situation without re-grading the walkway adjacent to the foundation.

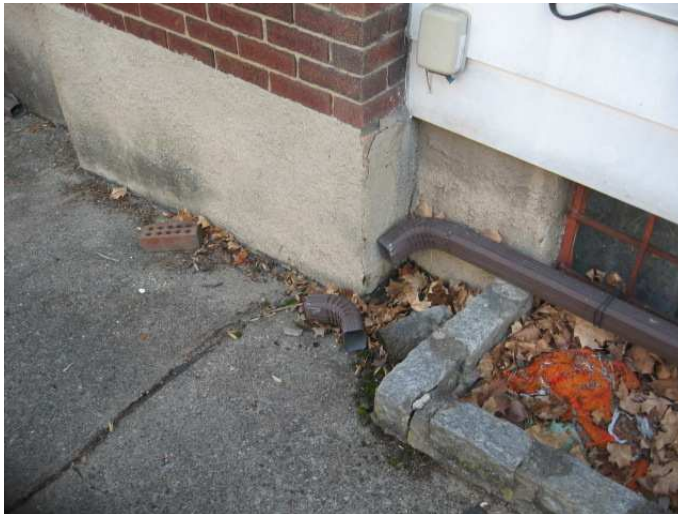
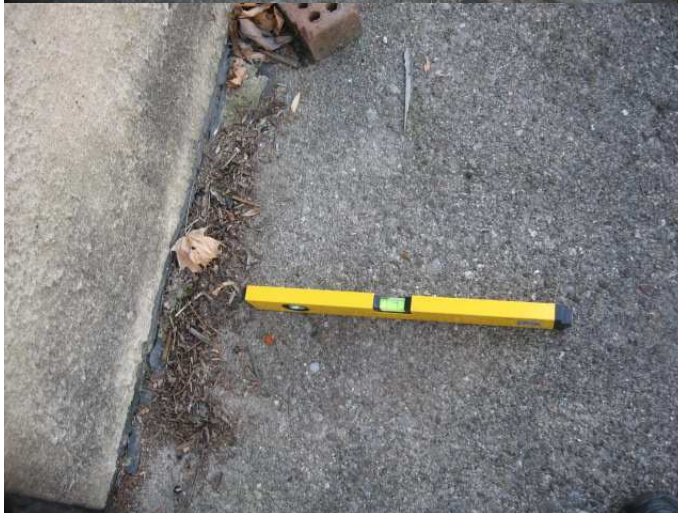
- **Repair:** Covers should be provided for basement window wells throughout to keep storm water out of the well.
- **Possible Major Concern, Monitor:** The driveway(s) appears to slope towards the house in various locations. This condition can cause water entry in the building. Unfortunately, it is difficult to improve this situation without resurfacing the driveway adjacent to the foundation or by adding a special intercept drain system.
- **Repair:** The driveway(s) should be sealed where it meets the house.

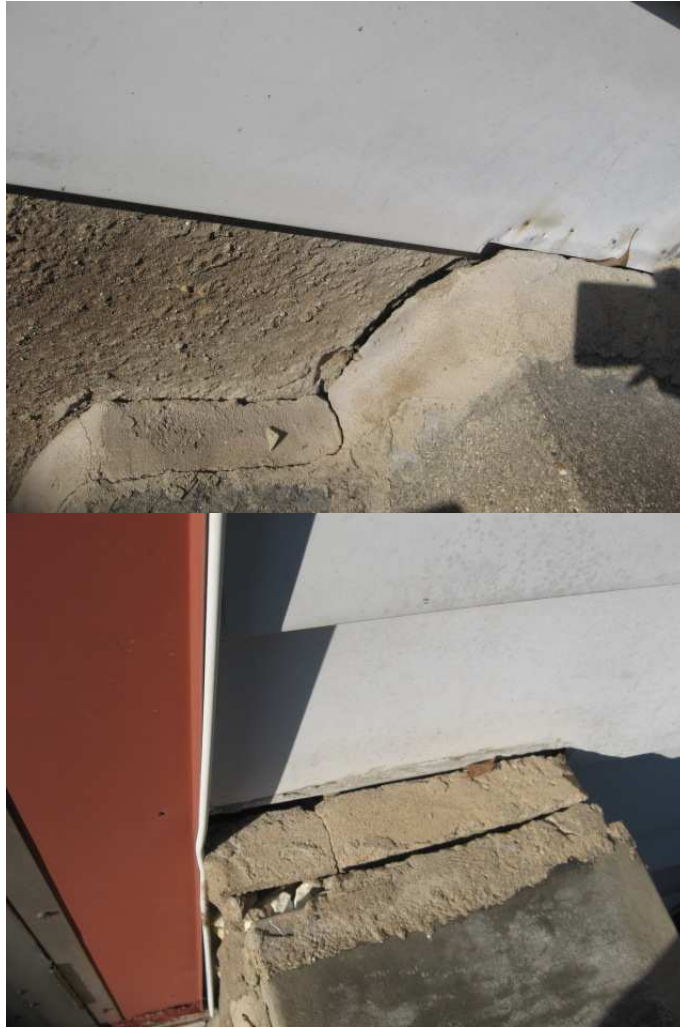
- **Repair:** The steps at the side wall have settled away from the house thereby posing a risk of moisture infiltration in the interior.

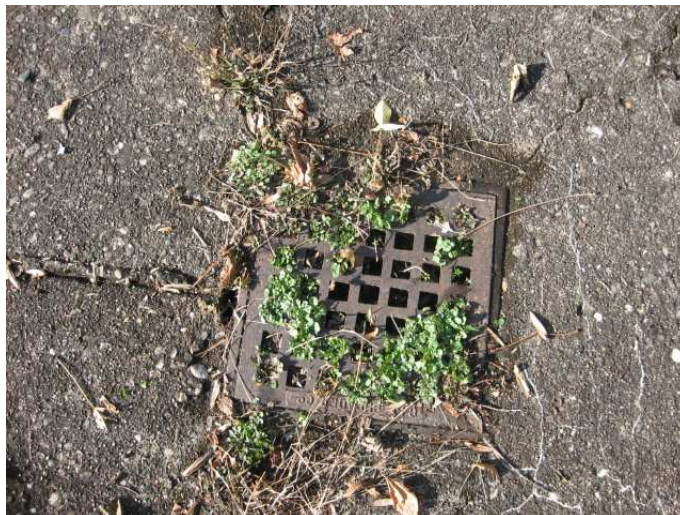
- **Repair:** The driveway drain is insufficient. A larger drain spanning the width of the driveway is recommended. Drive runoff must be directed away from the building to avoid water entry/damage. Additionally, the installed driveway drain is in suspect condition.

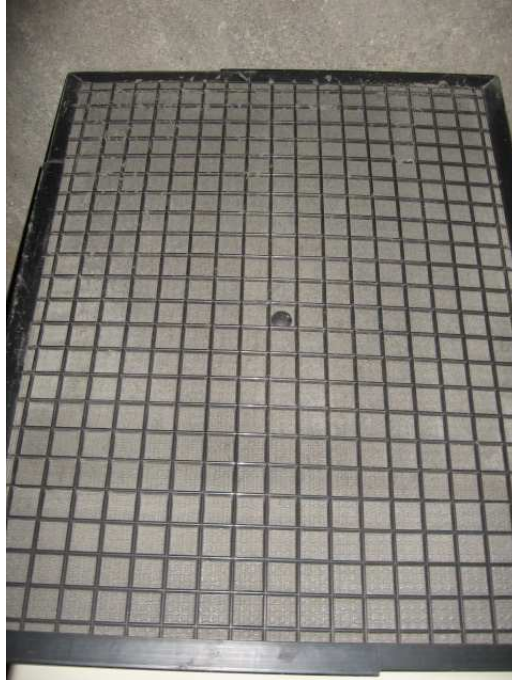
- **Improve:** The dirty air filter should be replaced. Also, an properly sized filter is recommended.

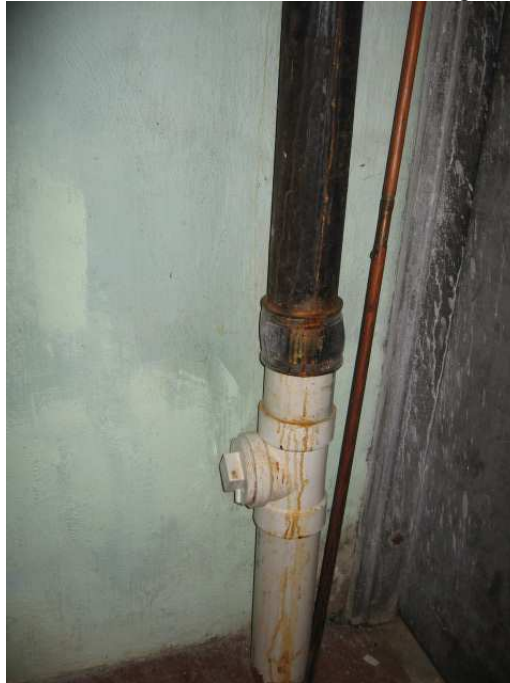
- **Monitor:** For the most part, the waste piping is old in various locations. It may be prone to unexpected problems. Improvement is recommended on an as needed basis. There was evidence of past leaks in several waste pipe locations.

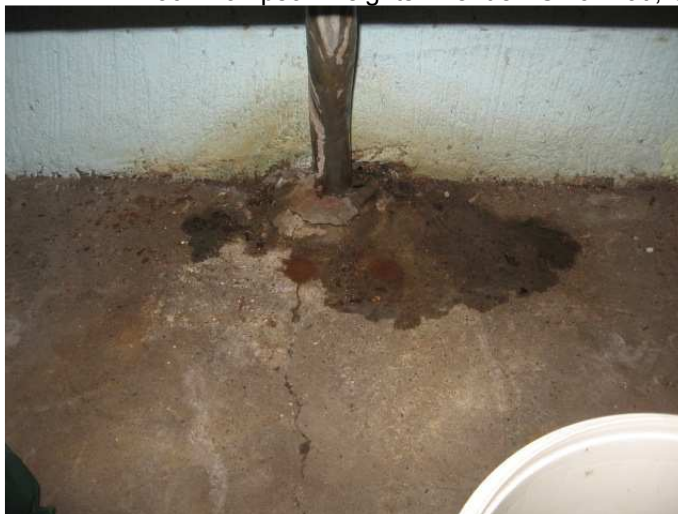
- **Monitor:** The sinks (kitchen & bathroom) were observed to drain slowly, suggesting that an obstruction may exist.
- **Improve:** Caulking improvements are needed for the kitchen and bathroom fixtures.
- **Repair:** The laundry tub leaks. Repair or replacement should be undertaken.

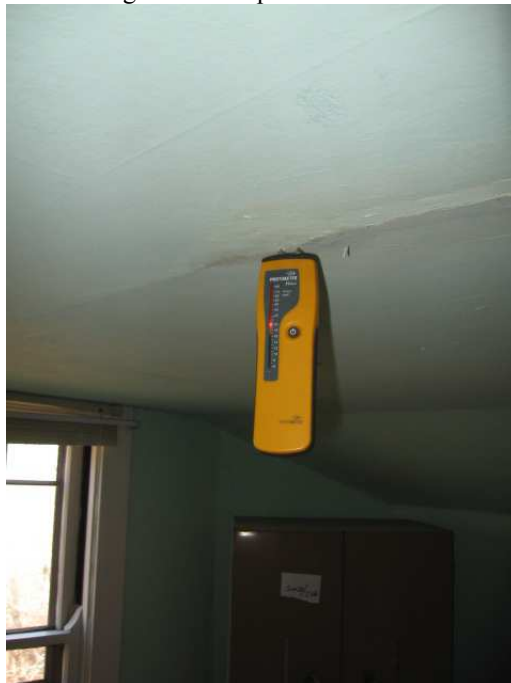
Rear Bedroom

- **Monitor:** Water staining was noted in various locations (bedroom(s), living room ceiling and etc). A high moisture reading was found on the rear bedroom ceiling about mid point.

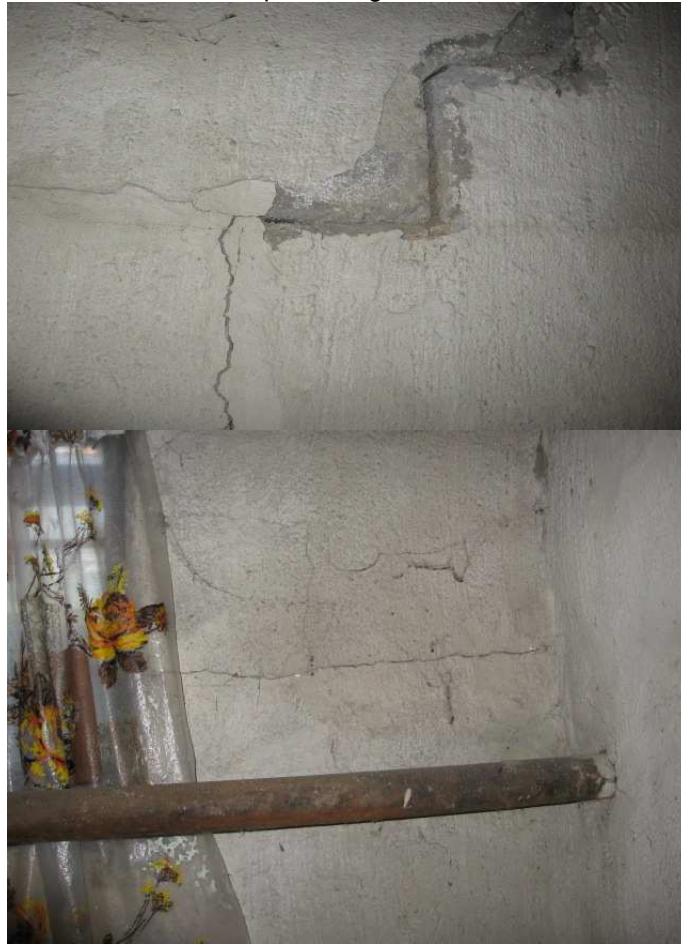
- **Monitor:** It is very common for shrinkage and/or settling cracks to develop in foundation walls, such as with this house. It is also common for these cracks to leak. If leakage is experienced, improve lot drainage adjacent to the crack. If leakage persists, various methods of crack repair are available. These include interior patching with an epoxy resin or hydraulic cement and exterior repairs after excavation. The exterior repair, although more expensive, is more often successful in eliminating leakage.

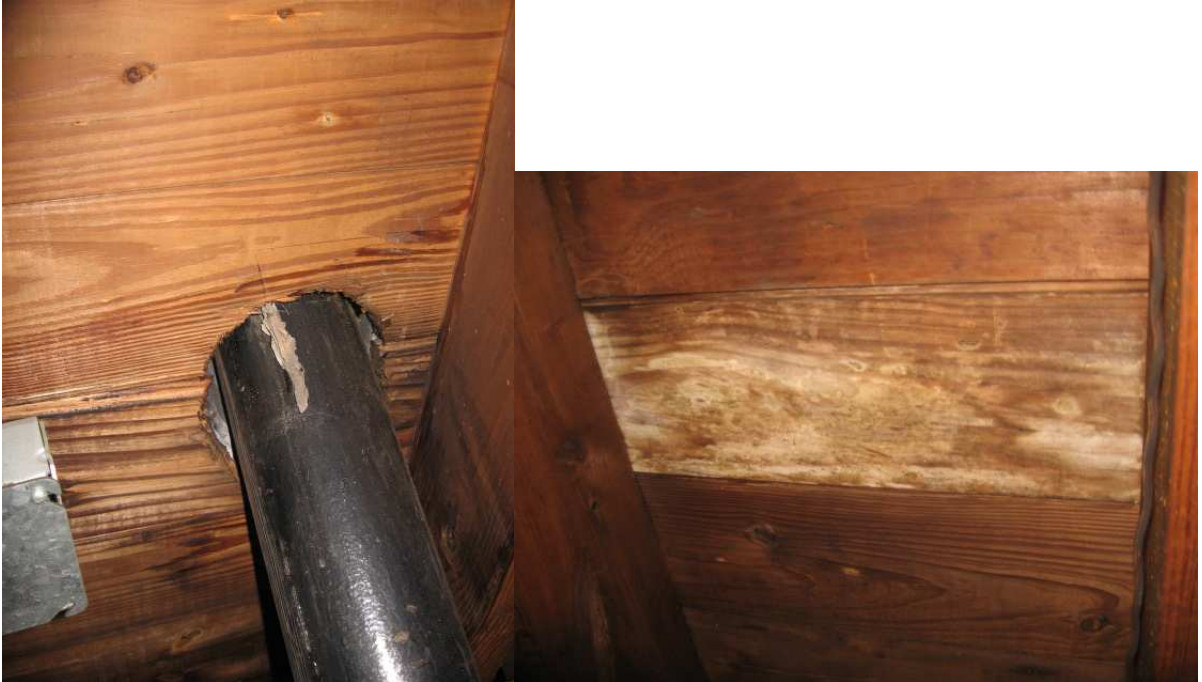
- **Repair:** Visible signs of mold(s) were observed in various locations:
 - 1- In various locations of the attic (underside of sheathing). The carpeting and debris (especially newspaper) should be removed from the attic floor. House To Home Enterprises LLC recommends sample testing (2) of the underside of the attic sheathing by a certified mold testing company. Note: Although there are more than 2 areas of discoloration throughout the attic sheathing areas, we are recommending a representative sampling for testing.

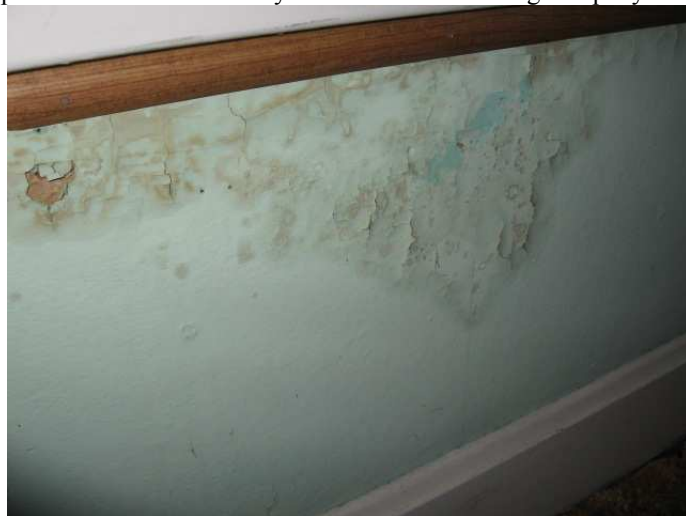
- 2- Discoloration resembling mold was found underneath the rear bedroom window. House To Home Enterprises LLC recommends that 1 sample be taken in this area by a certified mold testing company.

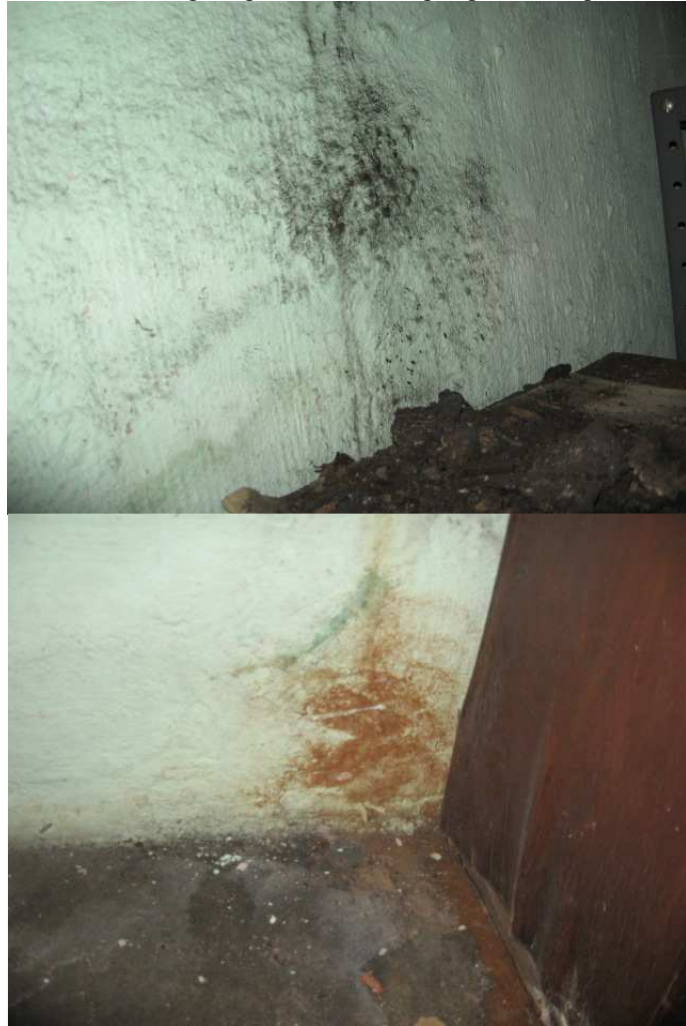
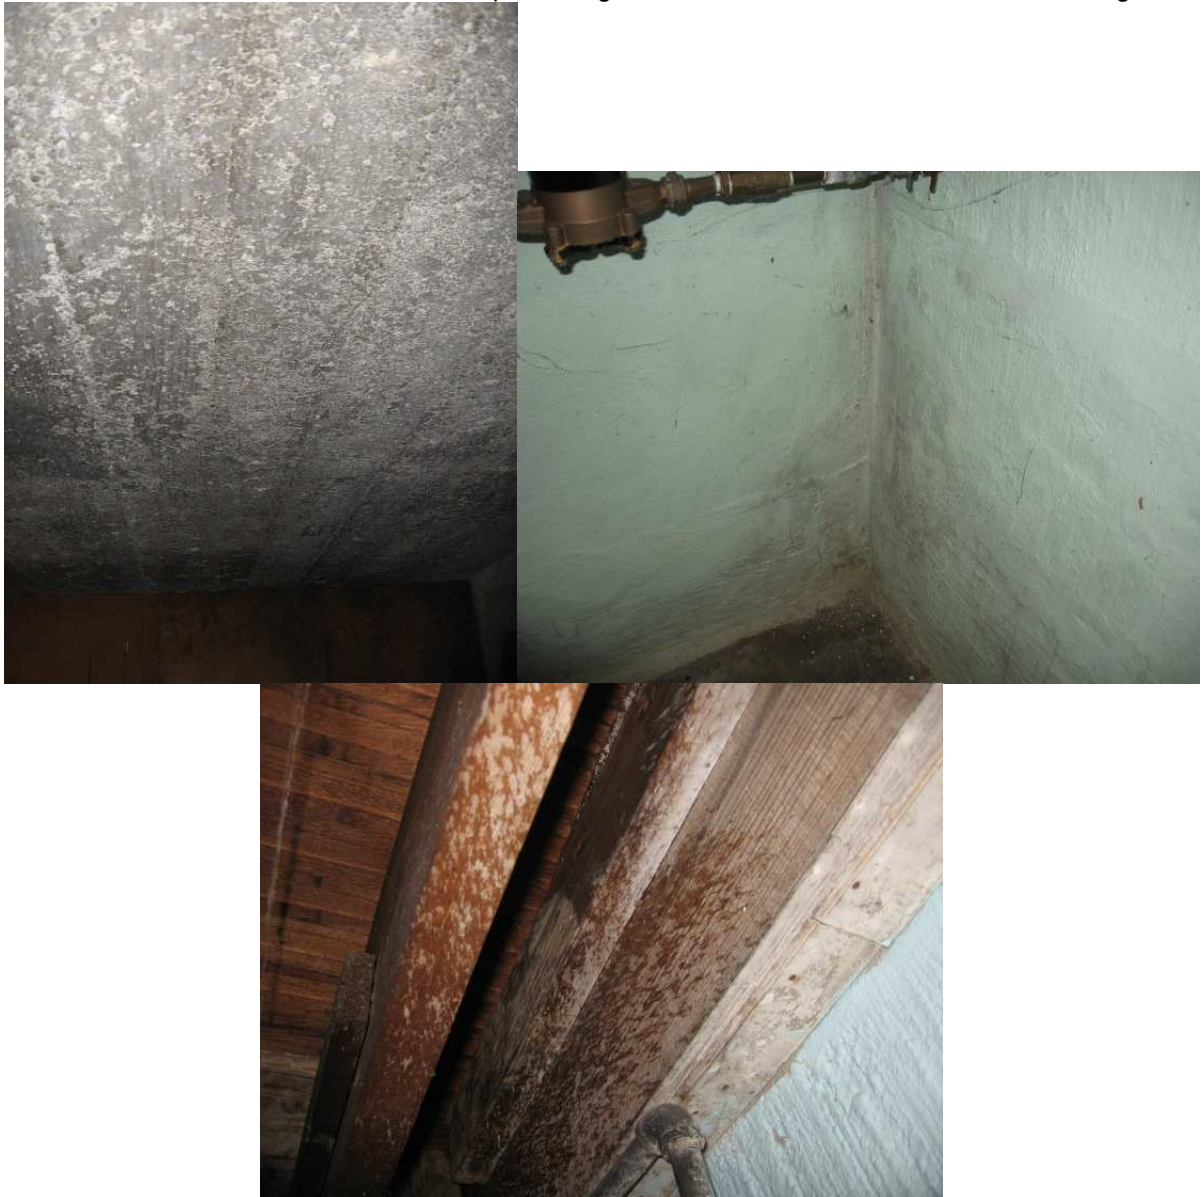
- 3- Discolorations on the basement walls/ceiling, floor structure, plumbing, HVAC ducting and etc was found in many locations throughout the basement (especially rear). Higher than normal basement humidity levels were found in comparison to the exterior and 1st floor (60% basement versus 28% exterior & 45% first floor). House To Home

Enterprises LLC recommends that samples be taken from the rear **floor structure area, side corner wall and ceiling (under front porch)** by a certified mold testing company. It is also recommended that any carpeting and debris be removed from the basement floor. **Note:** Although there are more than 3 areas of discoloration throughout the basement areas, we are recommending a representative sampling for testing.

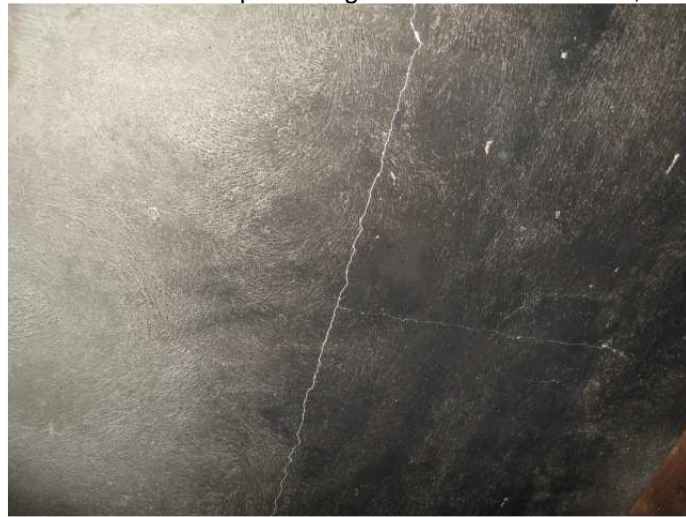
- 4- The attached garage exhibits signs of discoloration resembling mold on the ceiling. House To Home Enterprises LLC recommends testing by a certified mold testing company.
